Carpenter Bees

Susan C. Jones

Ohio State University Extension Fact Sheet
Department of Entomology
HYG-2074-06

Carpenter Ants

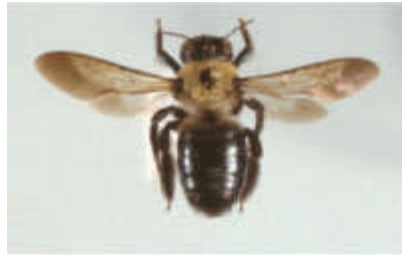
Figure 1. Carpenter bee.
(Courtesy of Kansas State University.)

Carpenter bees are large and robust. *X. virginica* is three-fourths to one-inch long, black, with a metallic sheen. The thorax is covered with bright yellow, orange, or white hairs, and the upper side of the abdomen is black, glossy, and bare (Figure 1). The female has a black head, and the male has white markings on the head. Carpenter bees have a dense brush of hairs on the hind legs.

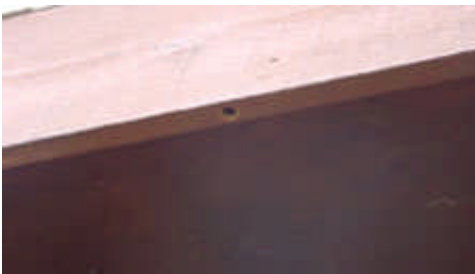
Figure 2. Carpenter bee entrance exposed in wood.

Carpenter bees create a nuisance by excavating round entry holes in wood (Figure 2) and depositing yellowish to brownish streaks of excrement and pollen on surfaces below entry holes (Figure 3). They also produce coarse sawdust from their

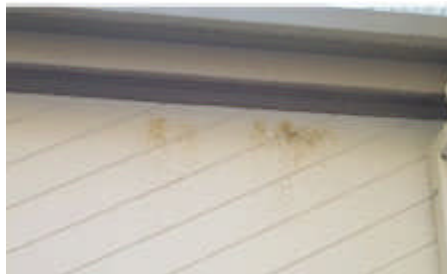
Figure 3. Carpenter bee staining on hole in fascia.

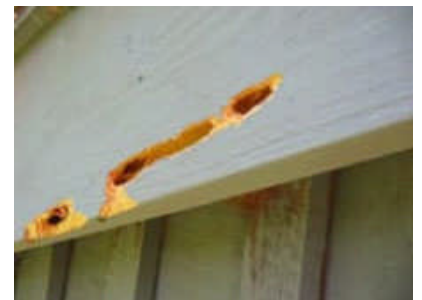
Figure 4. Carpenter bee gallery siding below the fascia.

borings. The carpenter bee gallery system is confined within the wood (Figure 4) and hence is not visible.

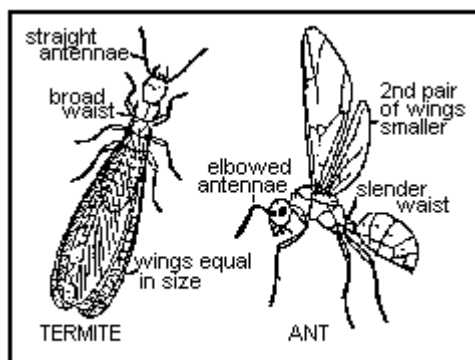
How to tell winged termites from ants

Winged carpenter ants can be distinguished from termites by their larger size and shape of their antennae, waist and wings.

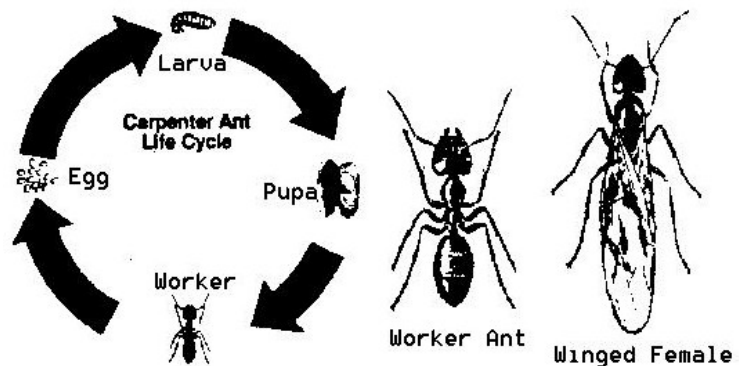
Carpenter ants are unusually large and blackish in color
