Buried Oils Tanks

By Randy Howland

Asbestos

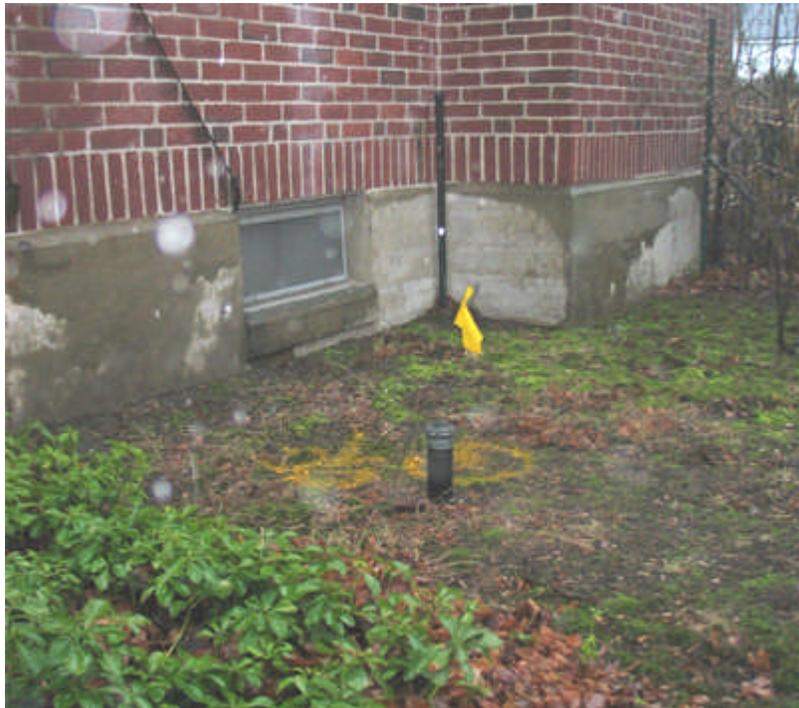
The principal element that deteriorates an oil tank is water. It is concerning, when water gets into a tank. The risk of water entry, through leaks in pipe joints or fills, is greatly increased when a tank is placed outside or underground. Once inside the tank, the water and sulfur present in the oil create an acidic mixture that corrodes its steel walls.

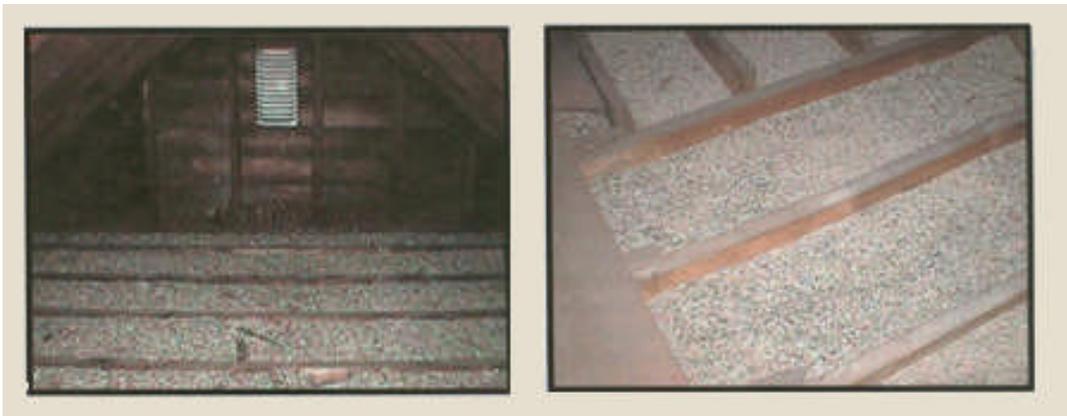
Vermiculite is a naturally occurring mineral. It resembles mica. All vermiculite ores contain a range of other minerals. A small percentage of vermiculite ores, from some sources, have been found to contain asbestos. Vermiculite is light weight, fire resistant, and odorless. These qualities have allowed it to be used in numerous products including attic insulation (as shown below).

1. The vermiculite insulation should be left undisturbed.
2. Items stored in the attic should not be located where the insulation can be disturbed.
3. If the house is to be remodeled, the insulation should be tested for the presence of asbestos and professionally removed, if found present.
