MONTHLY

News and Views from the Connecticut Association of Home Inspectors, Inc.

July 2006

Water Vapor Diffusion

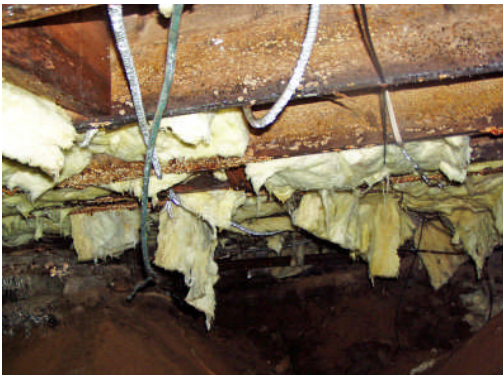
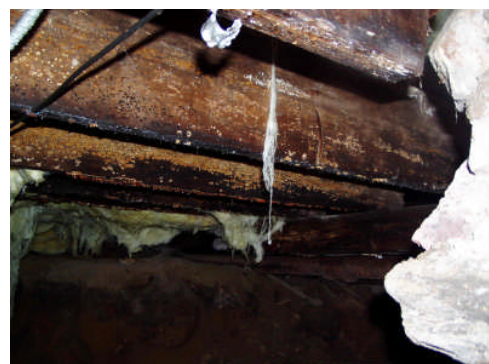
What can be observed in our inspection is that warm moist air is being drawn up into the wall cavities and other voids in the exterior of the home, and the water vapor is condensing when it is slowed down by the thermal insulation in the wall cavities. In areas in which there is no insulation, the moist air rapidly rises and is expelled through the gable vents and other openings. Where the owner had renovated the bathroom and kitchen is the area in which damage to the sills occurred and also the area in which the clad windows were found to be deteriorated. Wood decay was not observed in areas in which this older home had not been insulated.

In order to confirm these findings as well as to rectify a warranty claim made to the window manufacturer, the owner of the home volunteered to remove two of the windows in his home for us to evaluate. This was conducted by myself and a field representative from "Anderson Window and Door Corporation." We decided to remove one of the deteriorated windows at the north side of the home and one from the south side (weather side). The deteriorated window was removed and it was immediately noted that the lower jamb on both sides of

the window was rotted along with the right and left corners of the pine sill. We removed sections of the cladding along the lower jambs and sill and found additional deterioration. We also found evidence of mold and mildew along the paper of the interior sheetrock wall. We then removed the window on the south side of the home and found that the window was in perfect condition. The wall matrix at the south side was wallboard and plaster and was also in good condition.

The windows that were deteriorated did not fall into the category of being defective and the report was written that the cause of deterioration was due to high humidity levels in the home and poor ventilation. (The representative did replace the windows as part of a technical evaluation that would be used in their training program.)
