# MONTHLY

News and Views from the Connecticut Association of Home Inspectors, Inc.

July 2006

## Water Vapor Diffusion

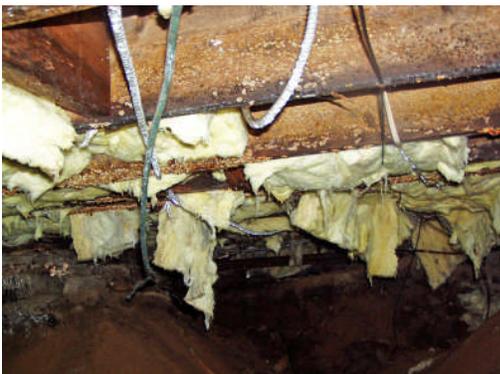
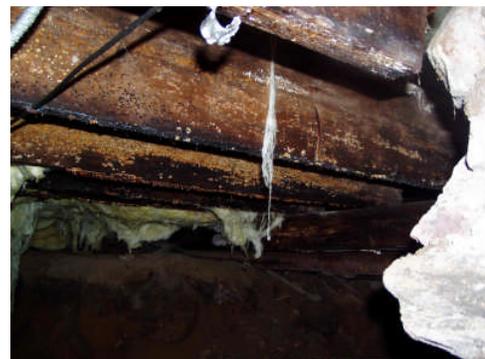
The inspection was performed in May. The outside temperature was 68° F, humidity was about 40% and the weather was clear. I began my inspection on the exterior of the home and noted the mildew staining around the gable vents on both sides of the home. I also noted that the vinyl siding was covered with algae on the north exposure. There was no vegetation overhanging the home, nor was there any large shrubbery planted against the foundation. I inspected the exterior window jambs and sills and found that by putting pressure on the lower jamb with my finger, water would be evacuated from the splice in the vinyl cladding. From these observations, it was apparent that a moisture problem was occurring within the home and further analysis would be required.

We moved our inspection of the premises to the basement of the home which was accessible by a "Bilco" steel hatchway on the west side of the home. The first thing I noticed was that the headroom in the basement was about 5'10" and I am 6' tall. This was noted by my hitting my bald head on the header as I entered the basement. The air in the basement was thick, indicating high humidity levels. I took a humidity reading and found it to be in the range of 88% with the basement temperature being about 64° F. My next observation was that the insulation installed between the basement floor joists was wet and dripping water vapor in some areas, whereas in other areas of the basement it was completely dry.

I began to probe the floor joists and use my moisture meter to indicate what the moisture content of the wooden structural members was and also to map out the areas of higher moisture content. This procedure was also applied to the girder and to the mud sills. After documenting the areas of high moisture content, it was obvious that high levels of humidity were escaping the basement through the path of least resistance in the wall cavities and vacating through the attic gable vents. Other areas of the basement, the wood members, were soaking up the moisture and deterioration was occurring due to fungi. These areas were some of the same areas that had been repaired by using new pressure-treated sills and rim joists. What is required for "fungi" to grow and deteriorate wood? Moisture (high humidity), Temperature (40-100° F), Oxygen, and a Food Source (wood cellulose). If we removed any one of these components, we would stop the deterioration. We know that we can't remove the oxygen or the food source, as both of these components are needed. We can't drop the temperature below 40° F or the plumbing will freeze and it would be extremely uncomfortable in the home, nor can we afford to increase it to over 100° F. Keeping this in mind, the only component we can eliminate is the moisture (humidity).

What can be observed in our inspection is that warm moist air is being drawn up into the wall cavities and other voids in the exterior of the home, and the water vapor is condensing when it is slowed down by the thermal insulation in the wall cavities. In areas in which there is no insulation, the moist air rapidly rises and is expelled through the gable vents and other openings. Where the owner had renovated the bathroom and kitchen is the area in which damage to the sills occurred and also the area in which the clad windows were found to be deteriorated. Wood decay was not observed in areas in which this older home had not been insulated.
